Resilient Waters

Tide Gates, Flood Gates, and Fish Passage on the Lower Fraser

A literature review and case studies from around the world

2021 by Resilient Waters

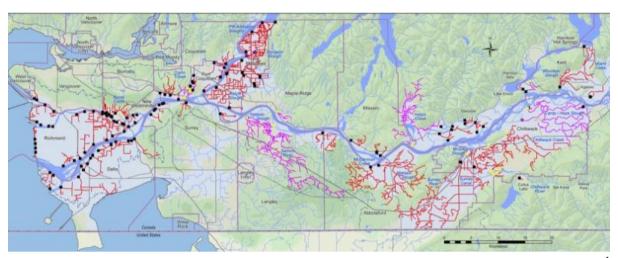
Map of the Lower Fraser River, depicting sites of flood control infrastructure and disconnected waterways ¹

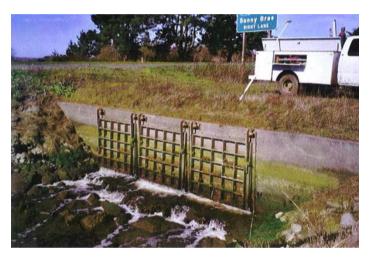
Old, cast iron tide/floodgate system 4

Many of these structures usually feature a simple design that blocks flow from a river or ocean from moving up a stream or across a floodplain, while allowing flow from a stream into a river or ocean. Top hinge gates were prominently and historically used for managing floods, however the top hinge design prohibits flows most of the time decreasing connectivity. This is due to their design and operation, as

they rely on head pressure to open, and their narrowness and infrequency of opening makes it almost impossible for fish to pass.

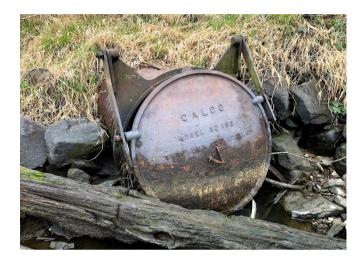
Still a popular design today, and the most prevalent design used in the lower Fraser watershed, older models of top-hinge gates are most often made of cast iron (while some more modern designs may use a lighter aluminum. The oldest structures can also be made out of wood. Due to the location of the hinge / fulcrum being at the top, it requires a significant amount of hydraulic head difference to open the gate. Due to this feature this style of gate has been widely installed throughout tidal and flood zones successfully preventing agricultural lands from flooding (Guillermo Giannico and Jon A. Souder, 2005).

Top-hinge style tide/floodgate (Pre-install) 5

Pros	Cons
 Requires little maintenance Heavy cast iron material keeps the device closed for long periods Efficiently prevents flooding from rivers and streams backflowing 	 Heavy cast iron material keeps the device closed most of the time, for longer than necessary Older wooden designs become waterlogged Collects debris Discourages and or prevents fish passage Default closed position

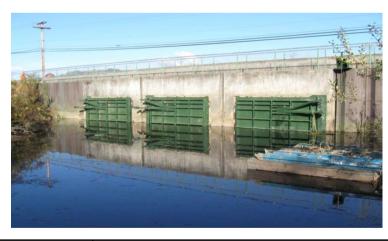
There are many different versions of side-hinged gates, most of which today are manufactured out of aluminum or stainless steel in a square or circular design attached to a culvert (sometimes integrated into cement). The aluminum gates are lighter in design and require little upstream water pressure to open. To ensure this function, the top side hinge should be installed closer to the

culvert's mouth which creates the restorative force (by creating a slight tilt) necessary for the gate to close (Guillermo Giannico and Jon A. Souder, 2005).

Side-hinged tide/floodgate array by Nehalem ${\bf Marine\ Manufacturing}^{\ \bf 10}$

Pros	Cons
Collects less debris	Can be more costly

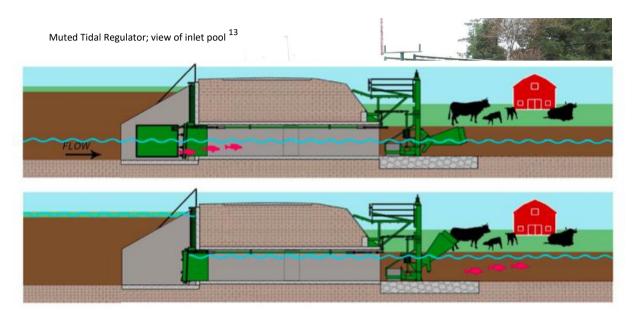
A Muted Tidal Regulator (known as an MTR) is another device invented by Nehalem Marine
Manufacturing and is often attributed to a side-hinged gate. This device features similar characteristics to the Mitigator Fish Passage Device but regulates based off of the flood elevations of the inlet pool. While most designs respond to tidal levels of the site-specific estuary, or area of incoming headwaters, an MTR responds to water levels behind the mouth of the gate (Guillermo Giannico and Jon A. Souder, 2005). This greatly increases connectivity and allows for greater control

and response to freshwater inflows. Again, similar to the Mitigator Fish Passage Device this design has been successfully adopted.

Diagram of Muted Tidal Regulator; depicting varying flows and function $^{14}\,$

Pros	Cons
 Default open position Adjustable floats Allows for greater tidal exchange Increases fish passage Allows for a greater response to freshwater flows Low maintenance (collects less debris) 	 Proprietary design (not easily replicable at scale) Can be more costly Can still discourage fish passage (to a much lesser extent)
